# **Appendix D**

## **Anomaly, Failure and Mishap Reporting**

In accordance with NSTS/ISS 13830, Payload Safety Review and Data Submittal Requirements, the AMS-02 Project has prepared this summary of anomalies, failures and Mishaps associated with flight and qualification hardware. This summary does not consider what are considered normal manufacturing deviations and discrepancies as failures or anomalies unless they rise to a clear safety impact status. All such manufacturing discrepancies associated with the AMS-02 Integration Hardware built and procured through Johnson Space Center are documented in the JSC QARC system.

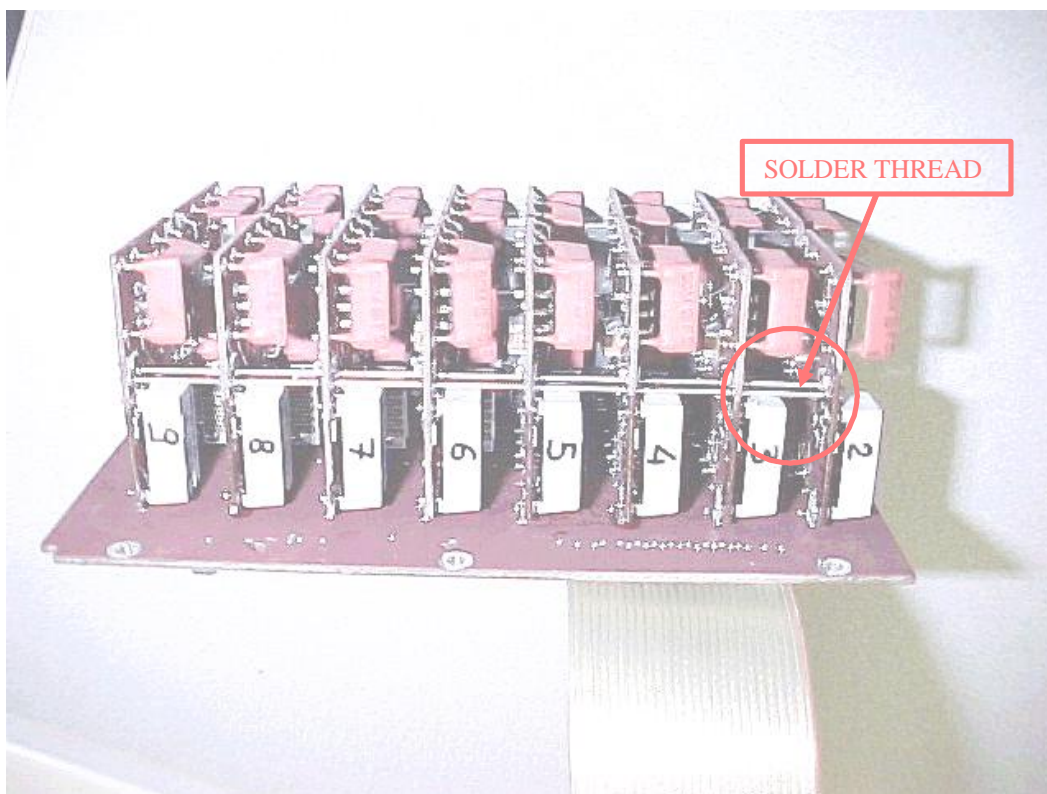
The *Linear Regulator* consists of a main board, with approximate dimensions  $5 \times 20 \text{ cm}^2$ , on which 16 *mini boards*, actually performing the HV regulation for each channel, are soldered in the vertical position (see picture 1). The soldering is done through *fork pins* which are shown in figure 2.

Picture 1 – side view of TOF Linear Regulator.

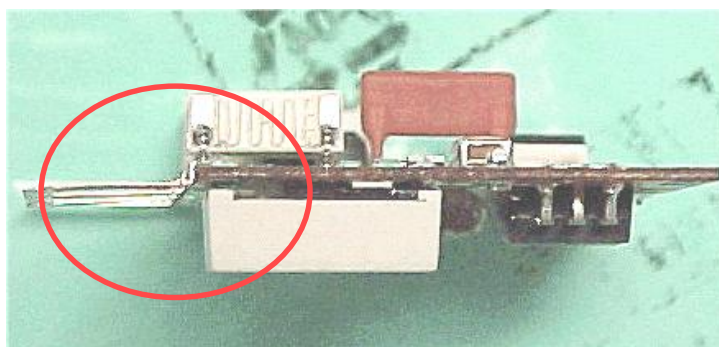
Picture 2 – View of the single regulator mini board with closeup of the straight pins used for the soldering of this component with the Linear Regulator main board.

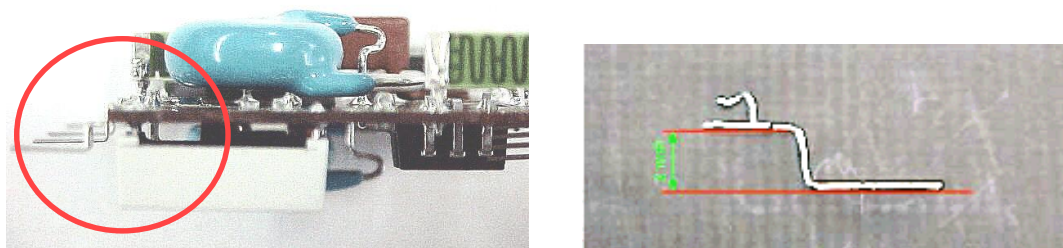
Figure 1 – New mini board with preformed pins(left). New shape of *fork pins* (right).

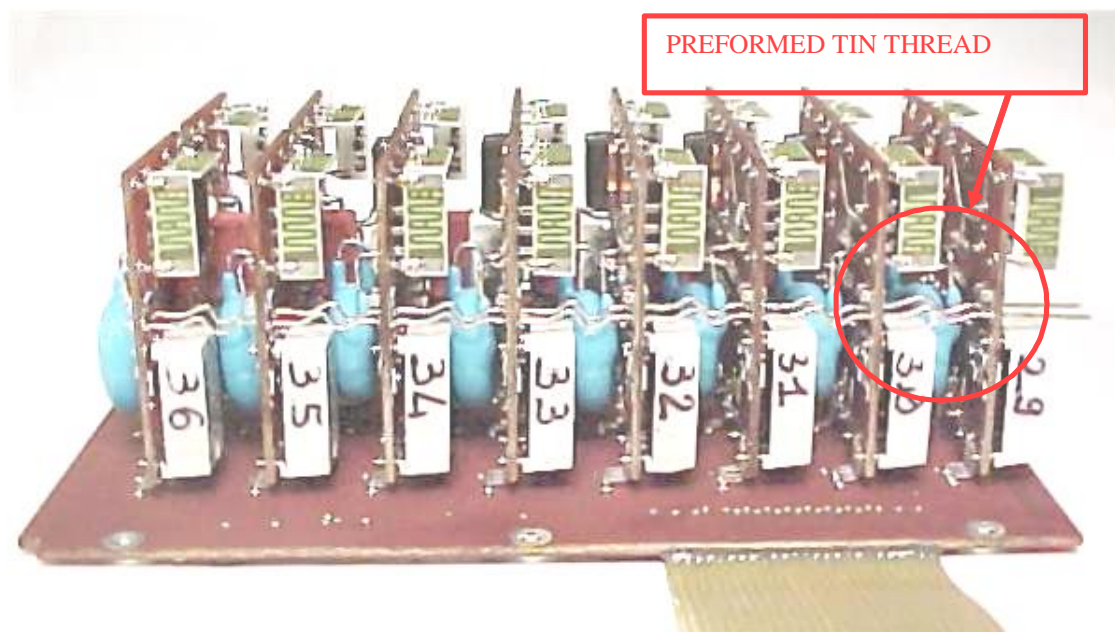
Figure 5

– QM2 test board. Also the interconnection thread has been preformed.

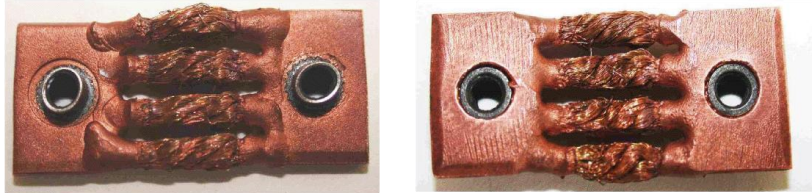
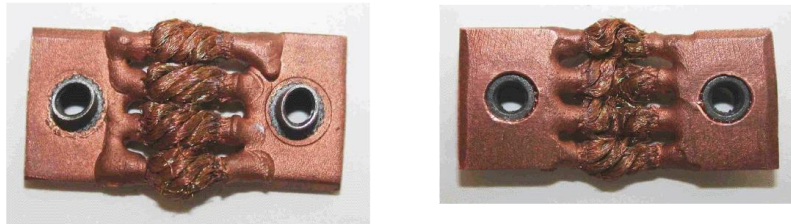
Observations: Some threads of the Copper braids used as thermal connectors between inner planes were found to be damaged during the assembly (*See Appendix A*). The damaged threads are broken on one side only and none was found to be loose. The loss of thermal conductivity is negligible.

Thermal bars are connected by thermal connectors made of Copper braids welded to small plates. Both faces of one connector are shown below:

Compression along Z-axis is applied to the braids in order to restore flexibility and to adjust the length in Z. Pictures below show a connector after compression.

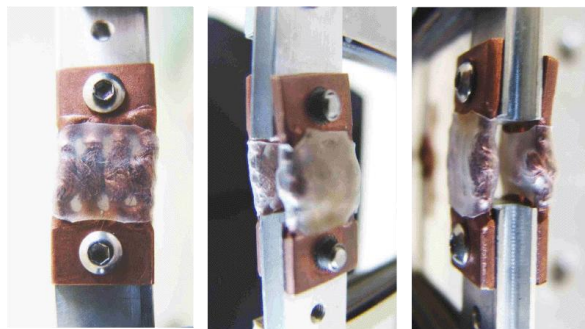
We studied the use of Kynar heat shrink tubing (space qualified) to enclose the Copper braids. Preliminary tests on prototypes are shown below:

Actions taken: Study of a containment procedure of the Copper braids using space qualified heat shrink tubing (*See Appendix B*). This tubing must be installed *in situ* after vacuum cleaning of the braids with examination of the filter. The heating should not damage the electronics.

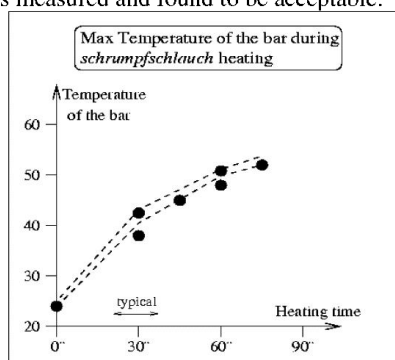
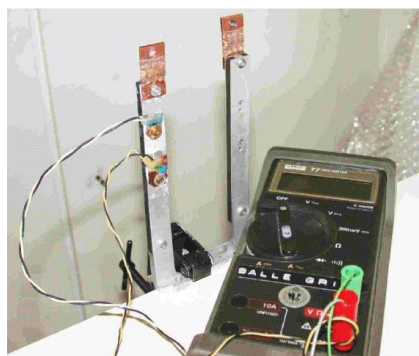
The tube is heated during ~ 30 seconds. The effect on the temperature of electronic hybrid circuits was measured and found to be acceptable:

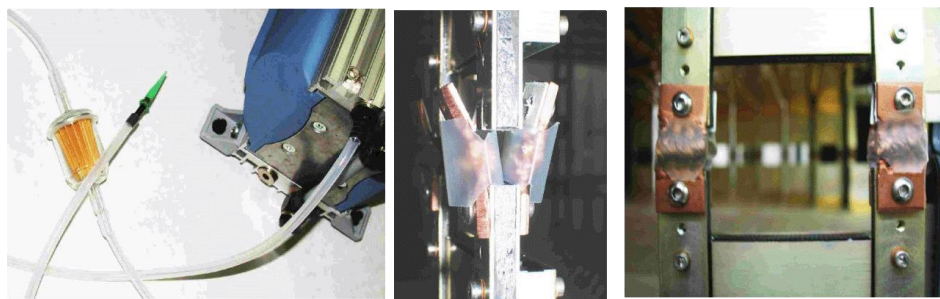
A procedure was established and was applied on all thermal connectors. A preliminary cleaning was made with a micro vacuum cleaner. The filter was examined. No broken thread was found in the filter.

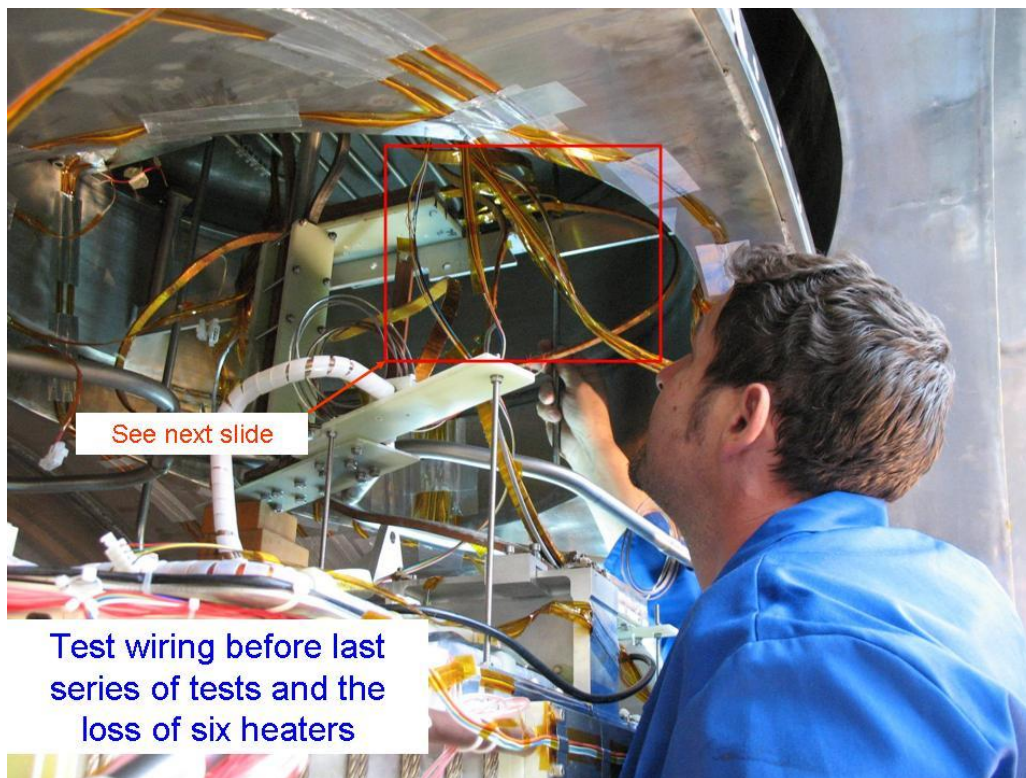
Figure 1: Test Wiring Before Magnet Testing

**Description of Event:** Prior to completing the assembly of the AMS Superconducting magnet, the magnet assembly was tested in a Magnet Assembly Test Rig. During this testing, several Special Test Equipment heaters were added to the magnet. These heaters were used to intentionally induce a quench in the magnet coils. Essentially, they were put in place to mimic the flight quench protection heaters or a random quench. The wiring for these heaters, which was also STE, was not adequately held in place to prevent movement during a quench. Essentially, the wires were bundled together with Kapton tape only (Figures 1 and 2). At the operating temperature of 1.8 Kelvin, the adhesive on the Kapton tape was not adequate to hold the wires together. During a magnet quench several of the wires experienced loads induced by the rapidly changing magnetic fields. These loads moved and pulled some of these wires out of the STE circuit board or the heater (Figure 3). The result of this was that several of the test necessary heaters to ensure no damage is done to the magnet were not functioning and the test had to be abandoned.

**Corrective Action:** Flight systems were not directly impacted by this event, however actions were taken to assure that all wiring for the flight system has adequate restraints to prevent movement and pull-out of necessary electronic equipment and wiring.

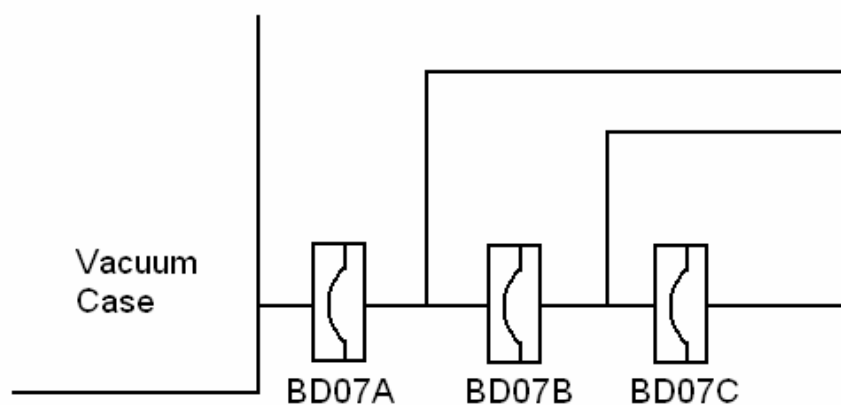
Figure 1: Vacuum Case Burst Disk Schematic

Originally, the system was designed with a single burst disk, which is typical for most high-performance cryogenic systems. At the Phase 0/I Flight Safety Review, the panel identified a new failure mode for the system. If the disk were to leak or spontaneously rupture within the atmosphere, air could enter the dewar's vacuum space. This would lead to a massive influx of heat into the tank of superfluid helium inside, which would cause it to rapidly warm up. As the helium begins boiling, the tank pressure would eventually rise to the burst pressure of the tank's burst disks and begin venting. If this were to occur during the point of maximum load during ascent, the Shuttle payload bay could be overpressurized. The panel therefore demanded a triple-redundant burst disk design to provide two additional levels of control against leakage. This arrangement is shown in Figure 1.

In the overall design, the original burst disk was called BD07, so in the new design, the disks were named BD07A, BD07B, and BD07C. Because the disks have a design burst pressure less than atmospheric pressure, vent lines have to be added to the interspaces between the individual disks to allow the air sealed in the tubes during manufacturing to escape. Otherwise, disk B and C would rupture when the outside atmosphere during ascent reached 0.2 bar. Given the small air volumes behind the disk, this would almost certainly lead to an incomplete rupture, which would prevent the assembly from providing the required overpressure protection. In Figure 1, these vent lines are shown as rising 90-degree bends from the interspaces.

This may seem to remove one level of safety control in the design, but in fact it has no bearing on the risk of leakage through the assembly discussed in the previous section. As shown in Figure 1, there was always a potential leak path through the vent tube in the BD07A/B interspace if a leak were to develop in BD07A. This potential leakage has already been assessed against the maximum credible leak used in the overall VC design and found to be encompassed by the existing analysis. In the new system, the potential leak path is through BD07B instead of BD07A, but this has no bearing on either the safety acceptance rationale in the overall safety analysis or on our compliance with it.

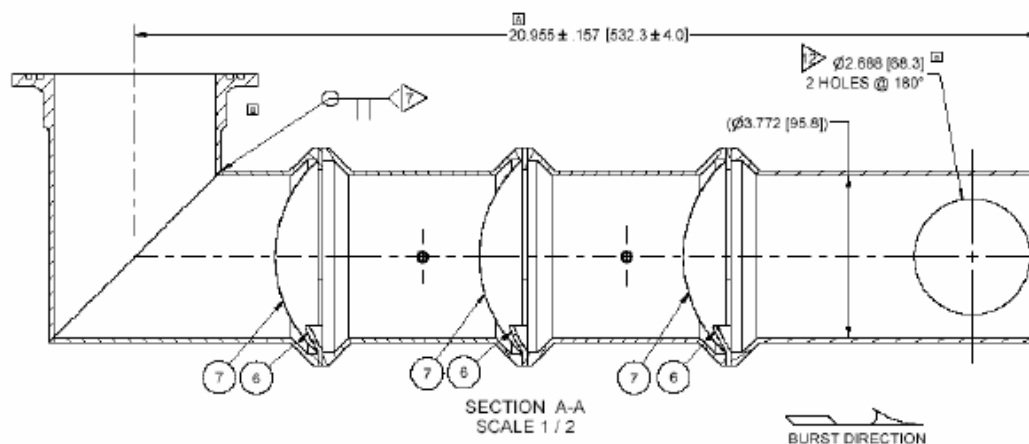
Figure 2: Burst Disk Assembly Design

The triple disk assembly was designed and manufactured by the Fike Corporation based on the schematic in Figure 1. The main vent channel has a large flange with redundant O-ring seals where the assembly bolts to a port in the VC. Figure 2 shows a section through the assembly. The small holes in the interspaces are the 0.25" OD vent lines, while the two 2.688" through holes are the zero-thrust vents for the exhaust.

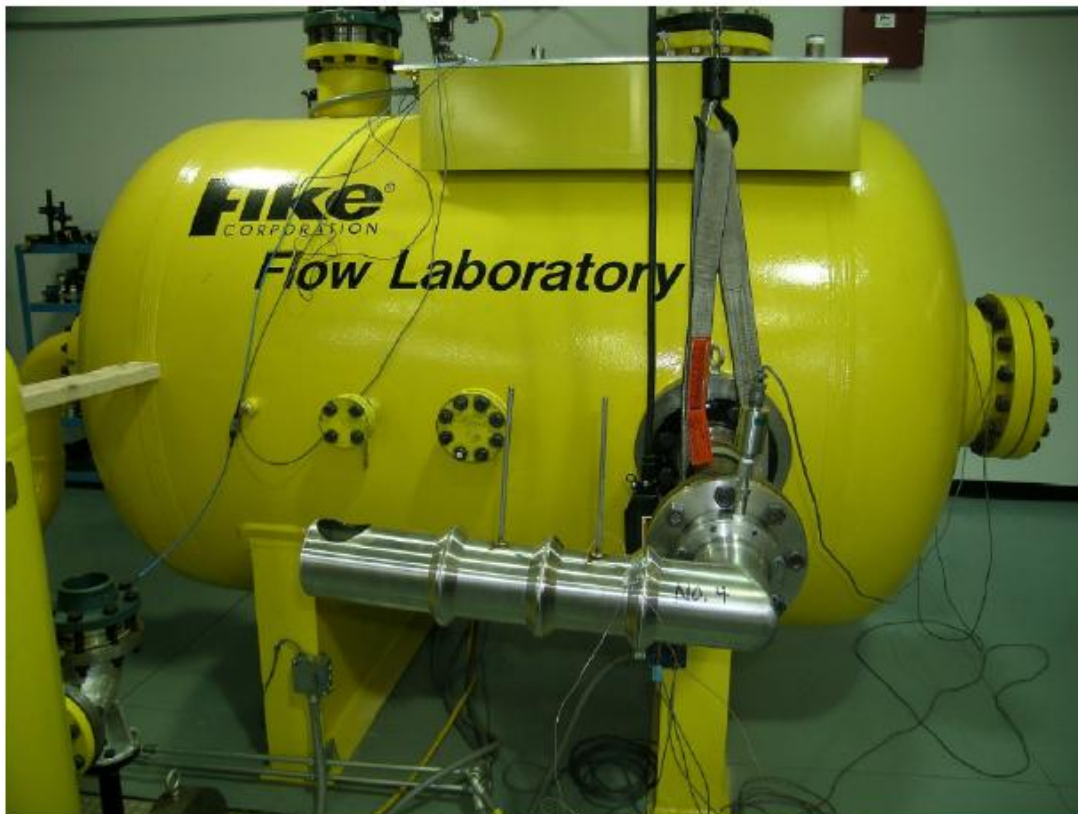
**Figure 3: Qualification Test Setup**

For qualification testing, each test unit was attached to a large pressure vessel filled with gaseous helium. Pressure in the space behind BD07 was allowed to rise slowly to the design burst pressure, at which point all three disks should have burst. The setup is shown in Figure 3.

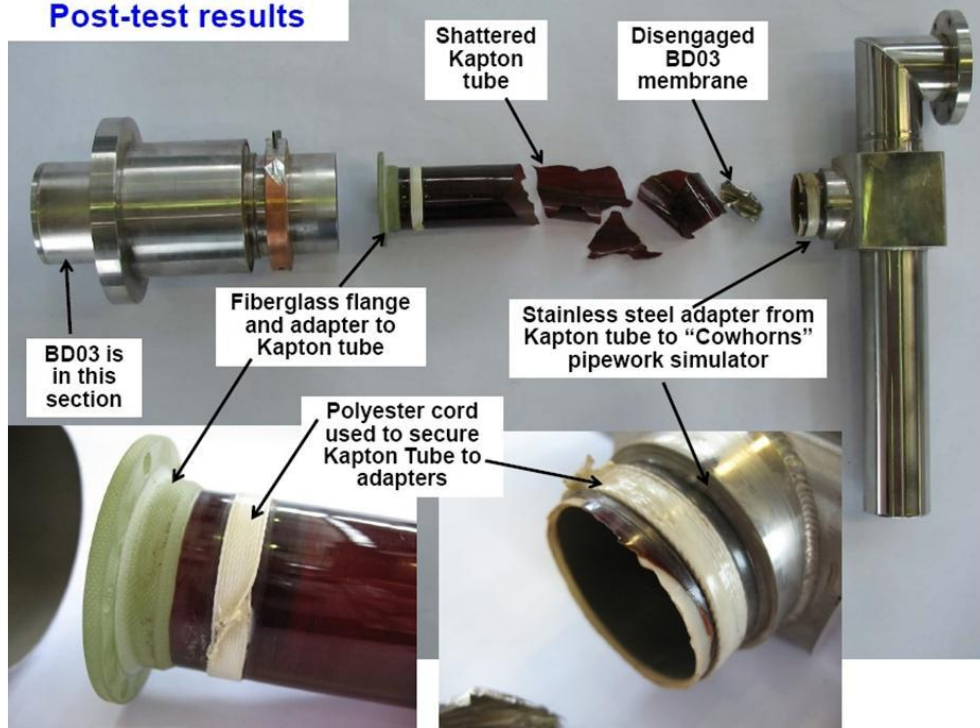
### Post-test results

- Since the test on July 9, 2009, the following has been determined
  - Failure of the burst disk membrane is believed to have been caused by a design flaw in the fiberglass flange used to attach the Kapton tube to the BD03 assembly. The flange, which was supposed to be at least the same diameter as the burst disk opening was actually 6.6 mm smaller diameter than the disk opening. This caused the membrane to impale itself onto the fiberglass flange, weakening the hinge line and causing the membrane to detach.

- Kapton tube failure could have been caused by the disk membrane impact or by the difference in the dynamic burst mechanism. All original tests were conducted with a pressurization rate of about 0 to 3 bar in 200 milliseconds. The burst disk rupture pressurizes the Kapton tube in about 4 milliseconds. The dynamic impact of this difference could have been enough to rupture the Kapton tube.

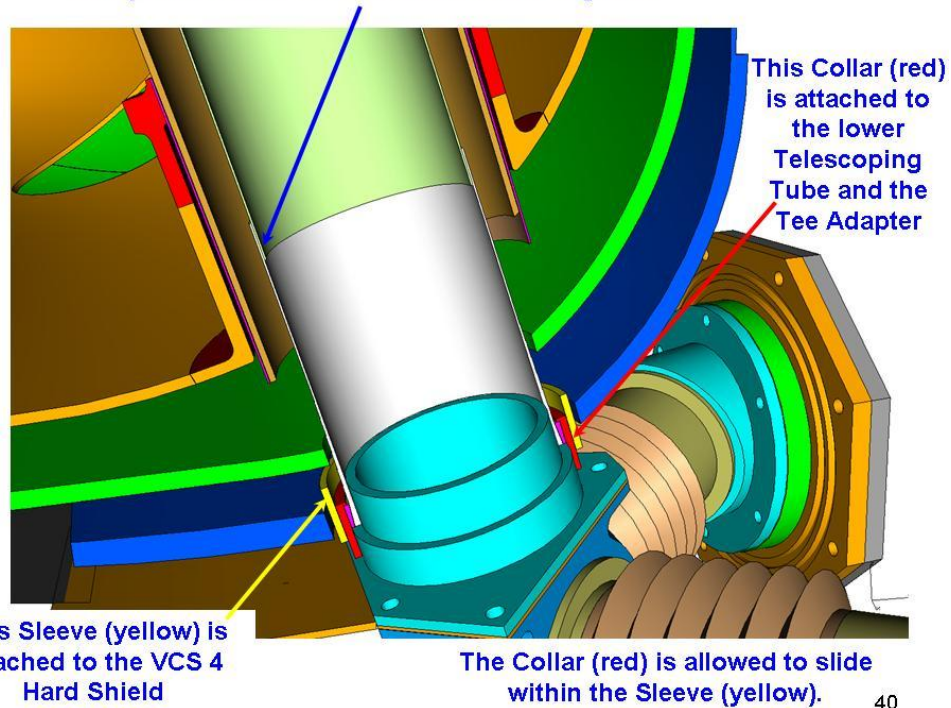
This joint is an interference fit that is also glued

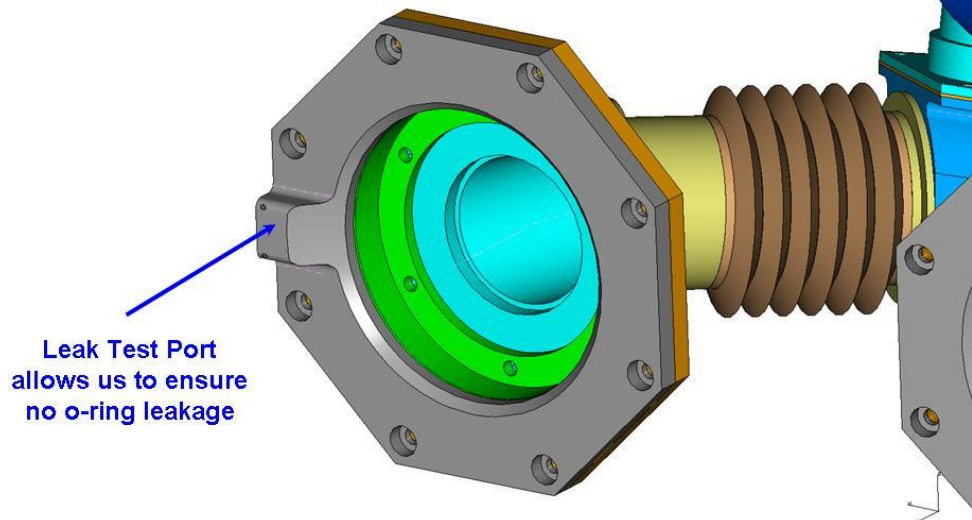
Leak Test Port  
allows us to ensure  
no o-ring leakage

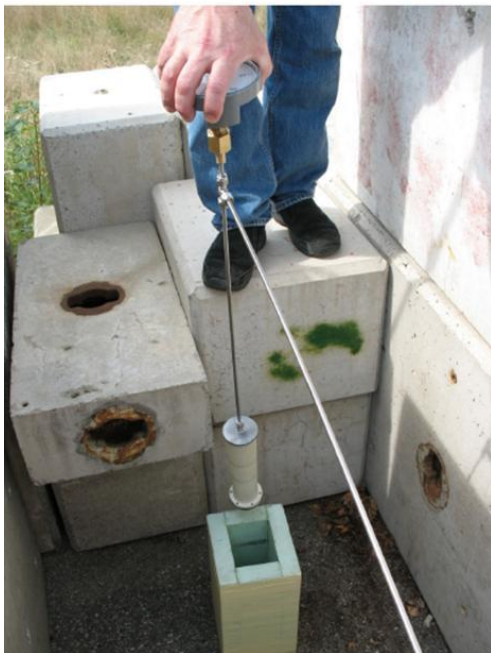
## BD03/06 Telescoping Tube Tests

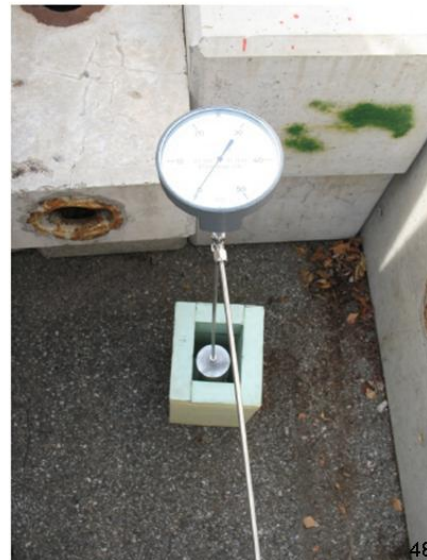
The tube was then placed in a small styrofoam dewar and connected to a 0-50 bar pressure gauge

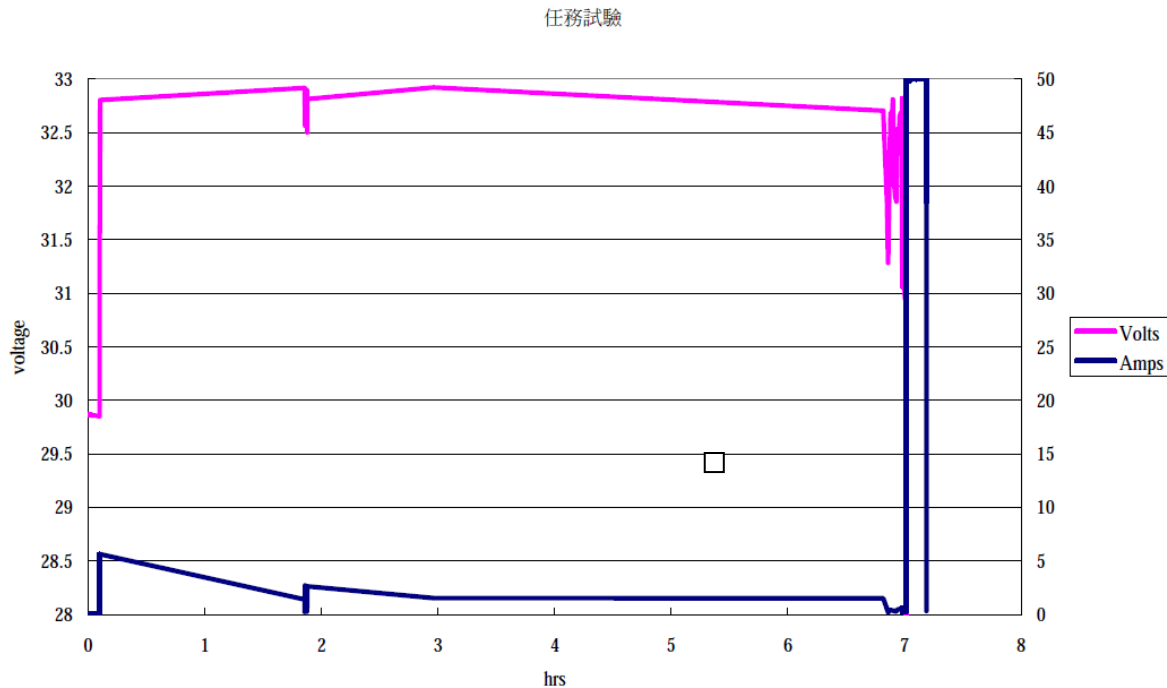
**Figure 11-2 Performance Testing of UPS.**

5. BMS charge enable signal was not implemented as an operational control. The charge enable signal from the BMS can not be used as an inhibitor or a disable for the External protection box we try to bought.
6. Parts of the top cover of UPS BOX had been melted due to high temperature (1759.0 deg. C) generated by battery short. J1 / J2 and two Test Connectors are all damaged. The equipment involved in this UPS EM charge failure event has not been tested or serviced following the event.

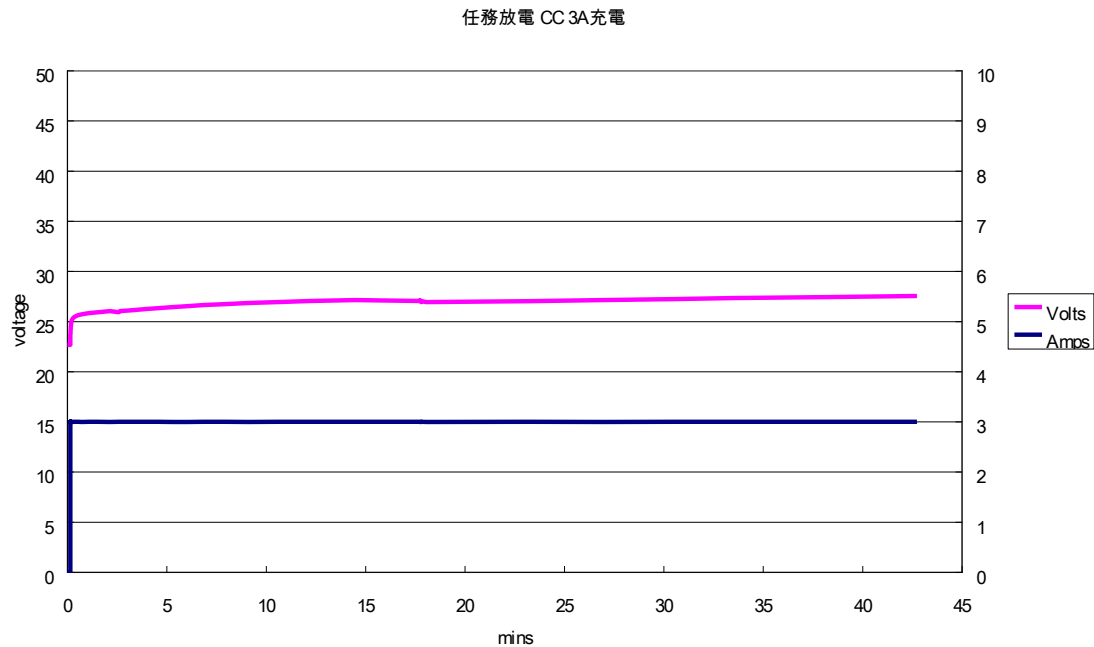
Graph 1: EDU was charged at 3 Amps for about 43 minutes.

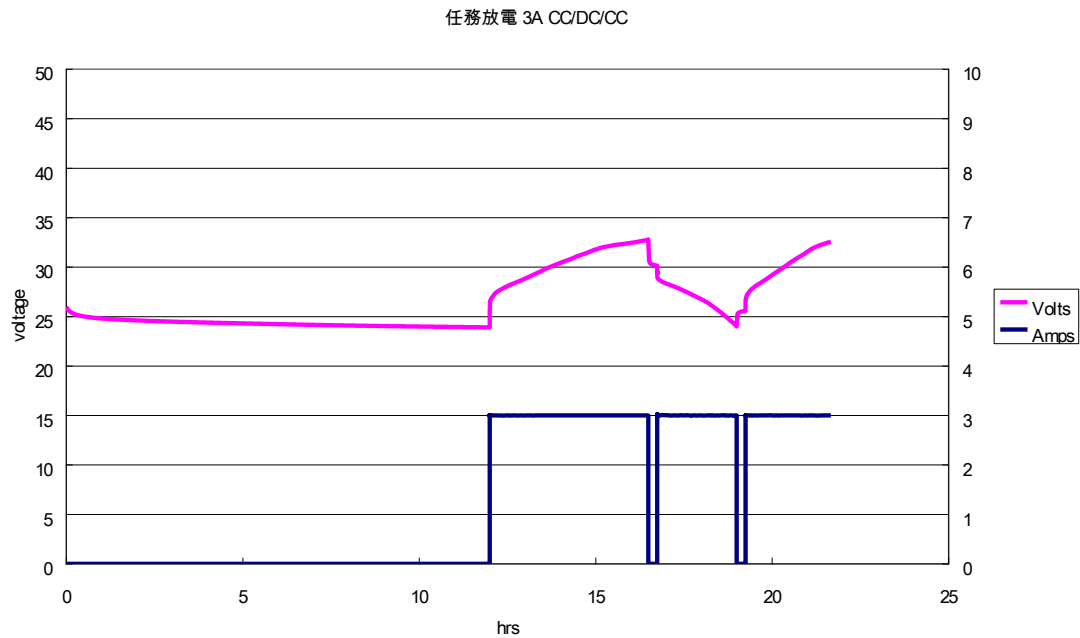
Graph 2: Open circuit for 12 hours then EM was charge/discharge/charge at 3 Amps.

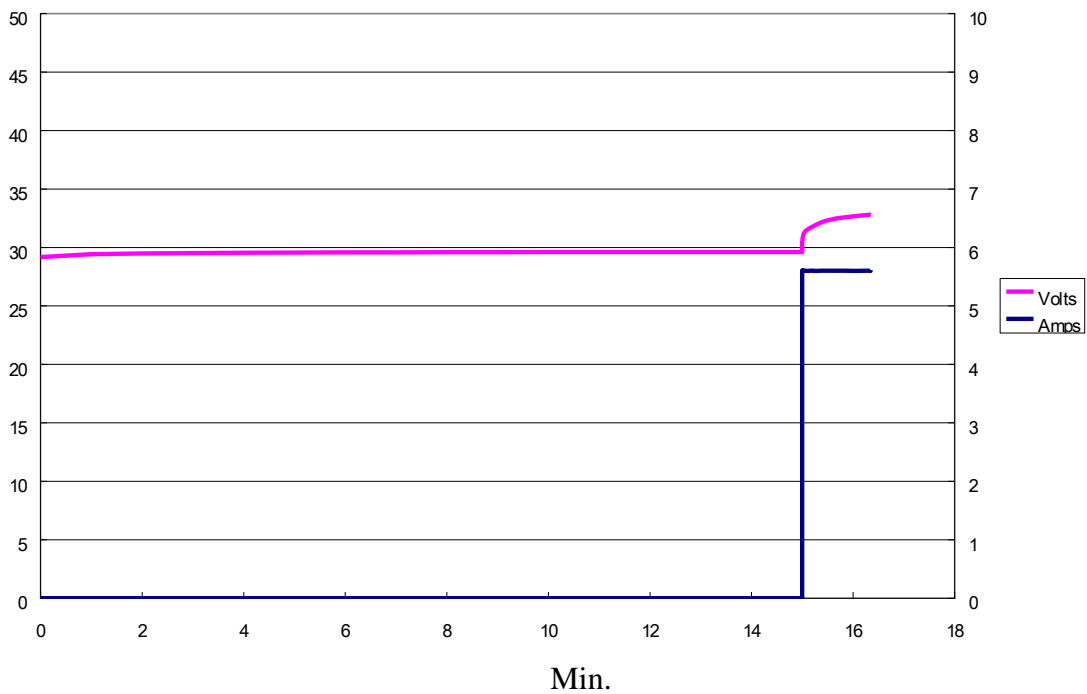
Graph 3: EM was charged at 5.6 Amps for about 1.3 minutes.

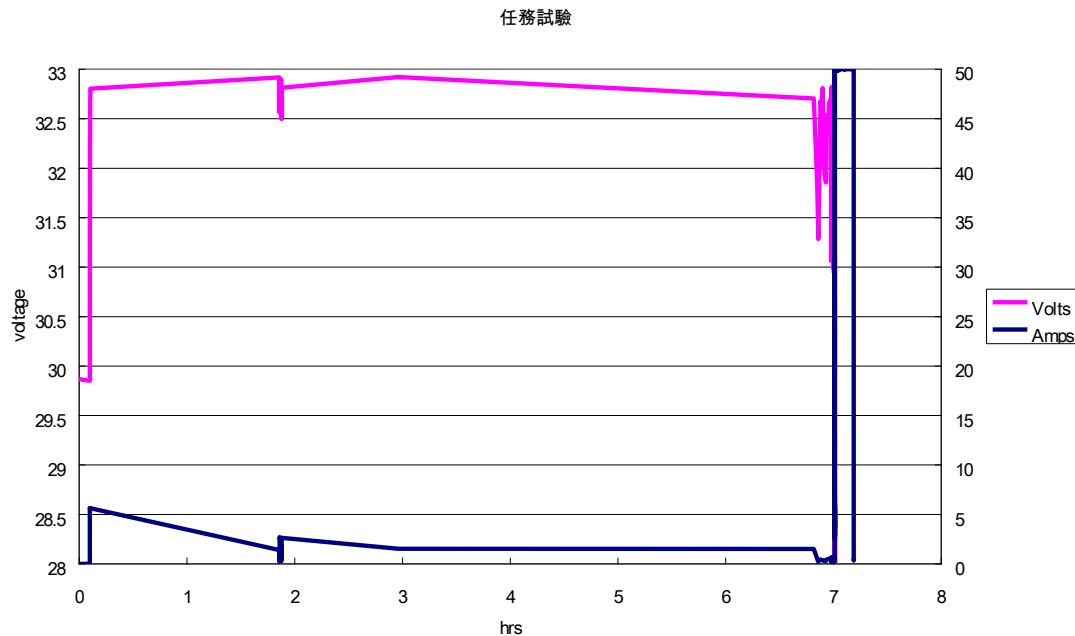
Graph 4: EM was charged at 5.6 Amps for about 0.3 minutes then EM was charged at constant voltage for about 7 hours.

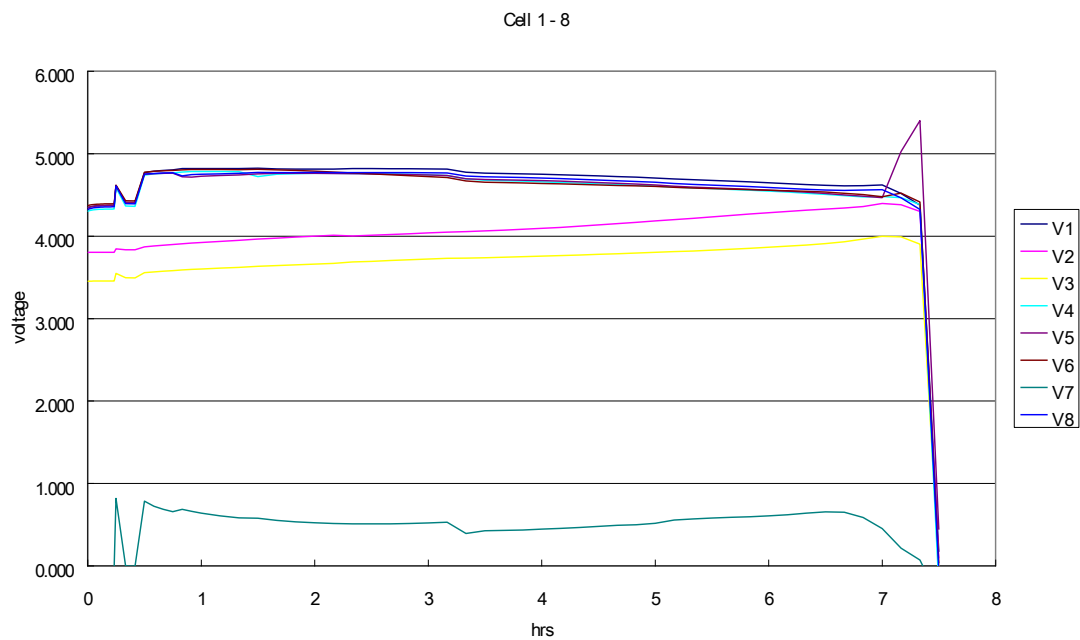
7. Unfortunately, only individual cell data of Graph 4 (attached) was taken by Digital Recorder (Accuracy is  $\pm 0.01\%$  of reading) due to restriction of the Recorder memory. Voltages of Cell 1 to Cell 8 are cited in Graph 5. At 15:53:02, voltage of Cell # 7 is -0.136 V and voltages of Cell # 2/#3 are 3.801/3.450 V. The battery was not well balanced after 1<sup>st</sup> charge/discharge/charge cycle. Voltage of Cell # 7 was below 1 volt during the Constant Voltage charging period. Voltages of the health Cells #1/4/5/6/8 are above 4.67 V at 16:41:04.
8. At 23:22:58 Voltage of Cell #5 was 5.011 V. At 23:27:14 Voltage of Cell #5 was 5.850 V.
9. At 23:35:28, V5 dropped from 5.521 to -0.077 V; V3 dropped from 3.899 to 0.479 V; V7 dropped from 0.067 to -1.070 V.
10. At 23:43:08 all cells went to zero or negative volts and the temperature at cell #5 was 1759.0 deg. C.

Graph 5: Voltage of Cell 1 to Cell 8

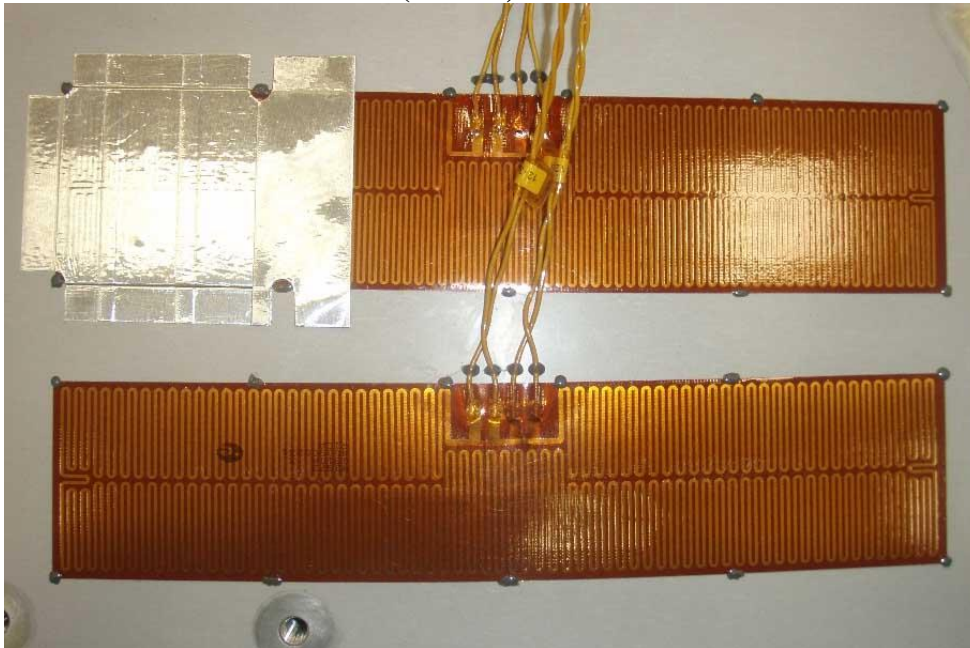
Figure A18-1 Example of covering heater with Kapton Foil Tape (Process incomplete for photo.)

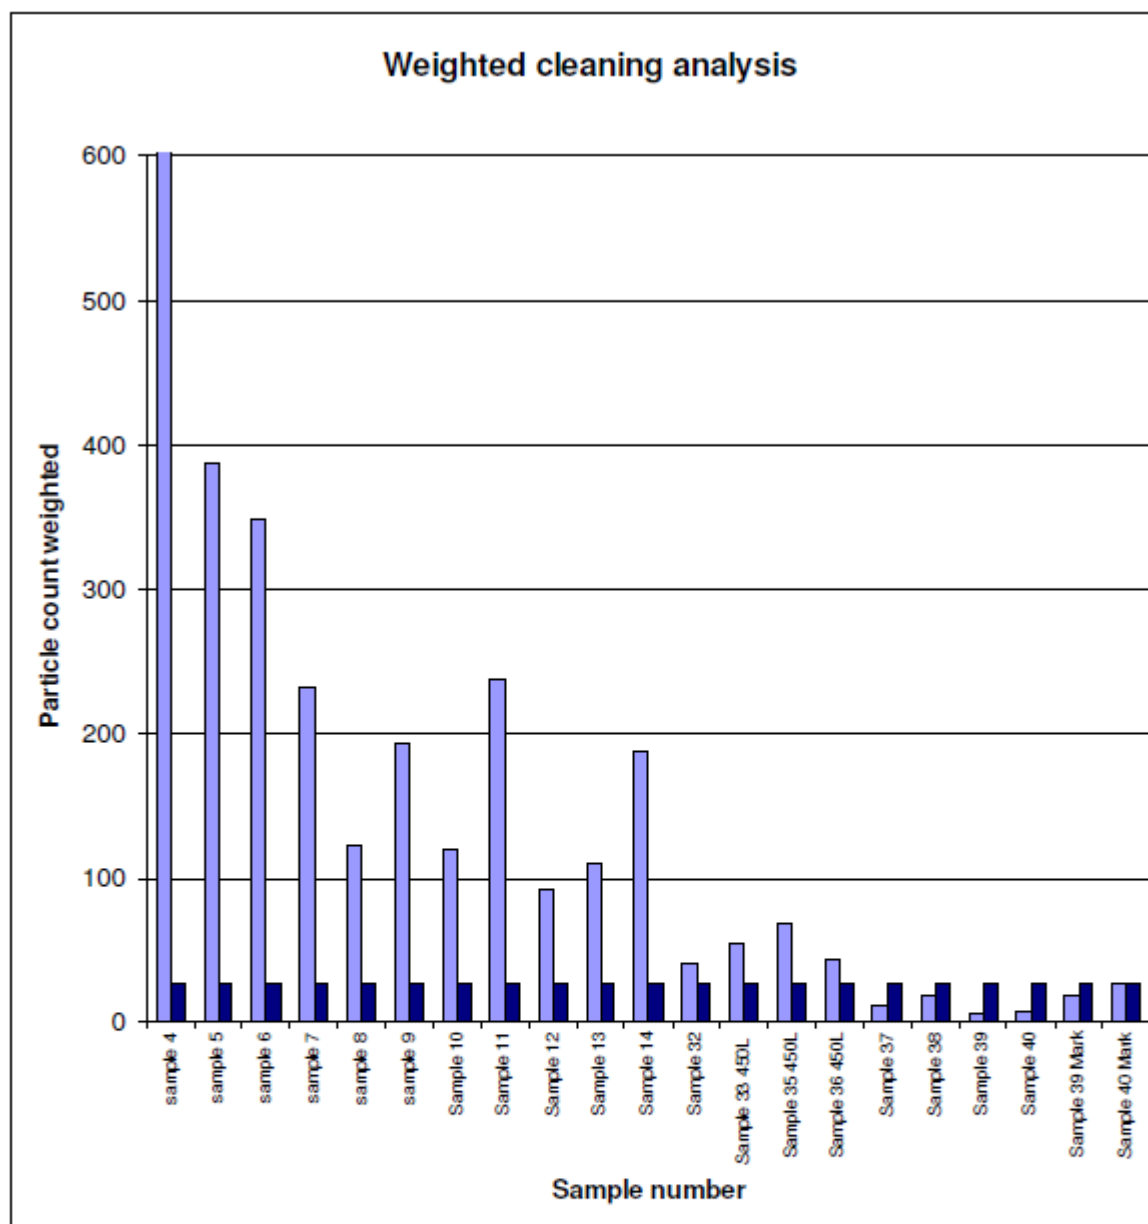
Chart of the 'weighted' particle size count against the IPA cleaning cycle number, showing the improvement in particle count as the cleaning cycles progress.

The dark blue bars show the Cleaning Specification requirement 'weighted' value of 27 units.

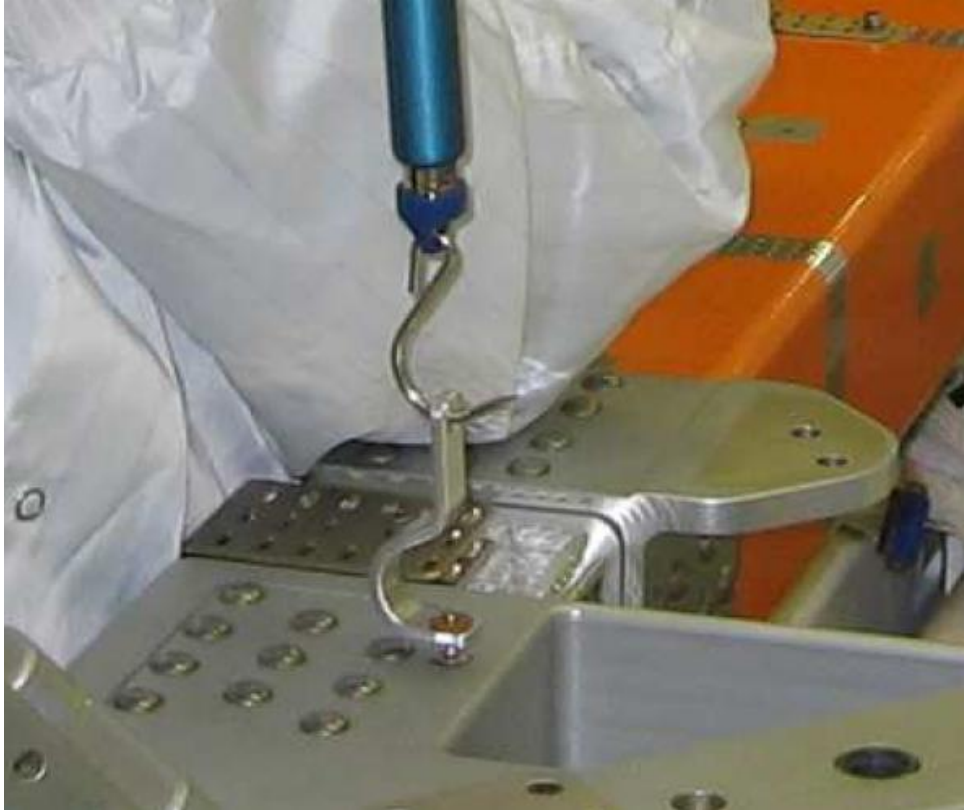
Tension Test Example

**Status:** Closed. Wednesday November 28, 2007 the pull test on all twenty installed pins were made to a minimum loading of 4 kg in tension (along the axis of the pin) and shear (a lateral force applied to the pin above the adhesion plane). All installed pins passed this test and were deemed adequately installed. This test was considered evidence that any future installation of pins that may support MLI loading per pin of 2kg or less based on a 10g acceleration condition would be enveloped and acceptable using this installation technique.

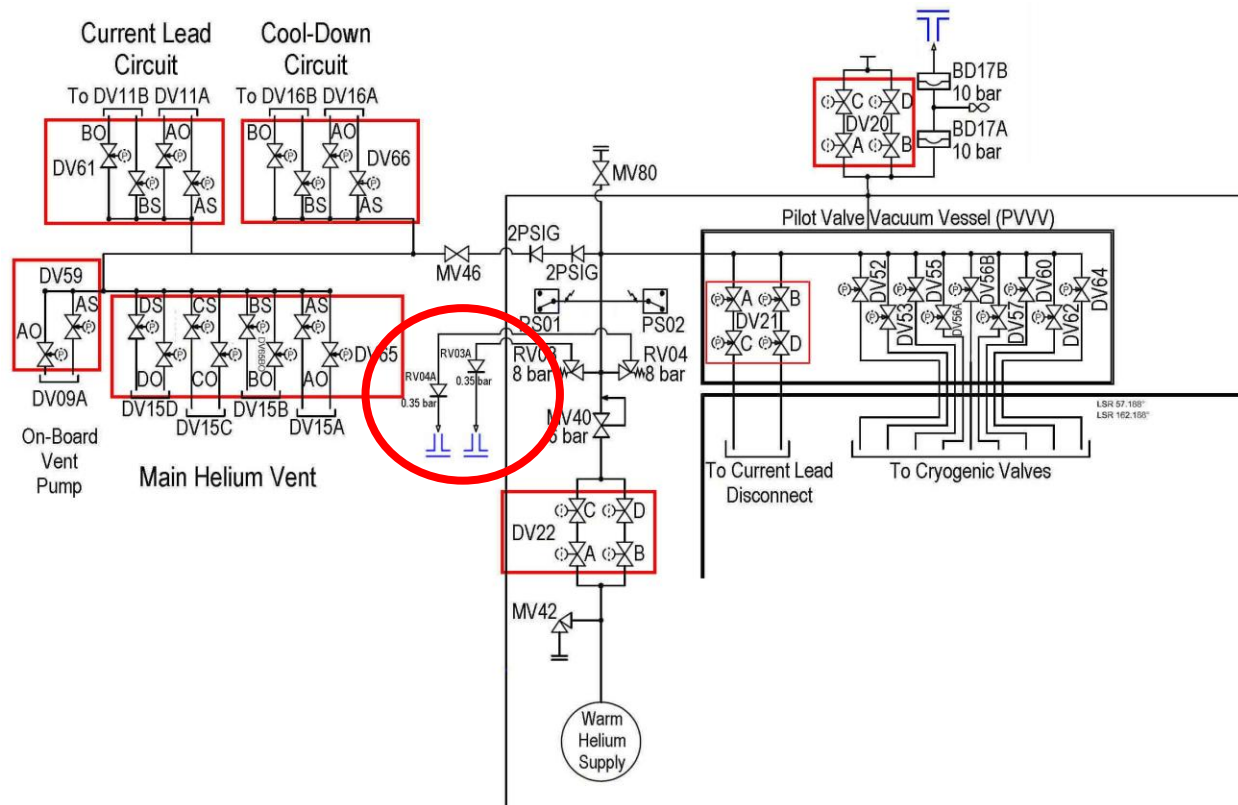
**Description of Event:** During operations a gradual pressure loss on the low pressure side of the Warm Helium Gas Supply was detected. The valve seats of the pressure relief valves were found to be leaking helium past them in sufficient quantity to be detectable and a nuisance to the Warm Helium Gas Supply system's operations and longevity.

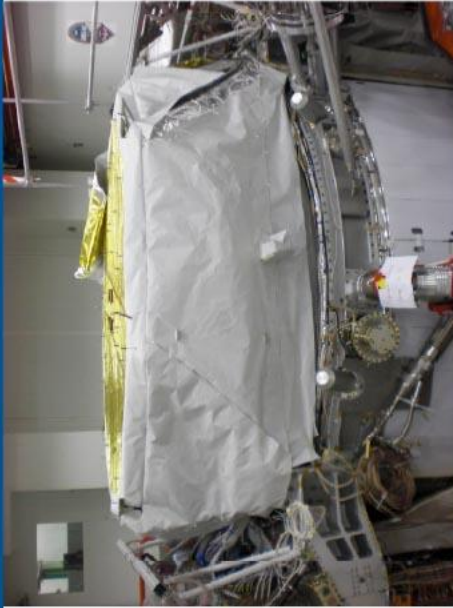
### Ground Heater Location

**Description of Event:** During ground processing at CERN, a fire event occurred involving the AMS-02 flight hardware. The fire was localized and resulting damage involved four MLI blankets (three damaged by fire, one damaged by need to access fire event location) and two flight electrical cables. To prevent frost/ice collection on piping to a minimum, a technician installed Minco foil heaters on flight piping. The foil heaters were wrapped around the tubing, not being applied flat but wrapped with inconsistent contact. To further complicate the thermal connection, foil heaters were wrapped around a bend in tubing, overwrapping with Kapton tape with just ends secured with aluminum tape. The implemented heater control circuitry used a single thermal monitor to control when to apply power, this thermal monitor was on a cold line while the “burned” heater was on an ambient temperature line at the time of the fire event.

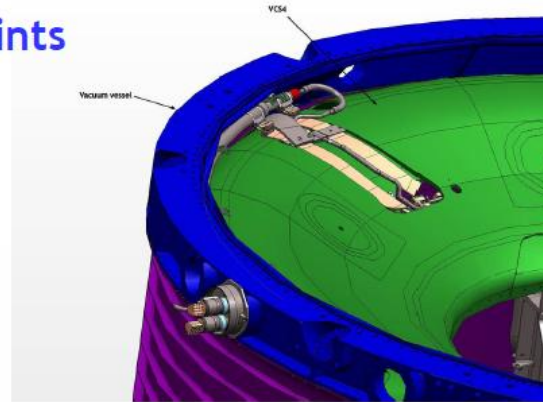
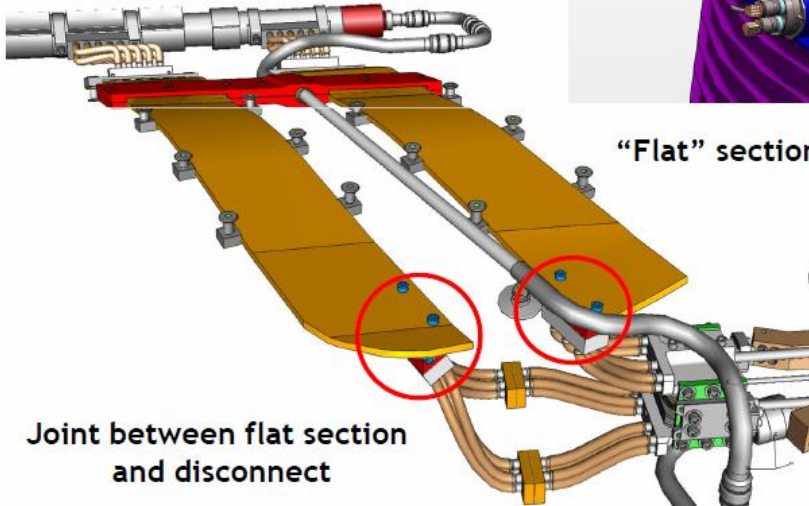
## Bad joints

Joint between flat section  
and disconnect

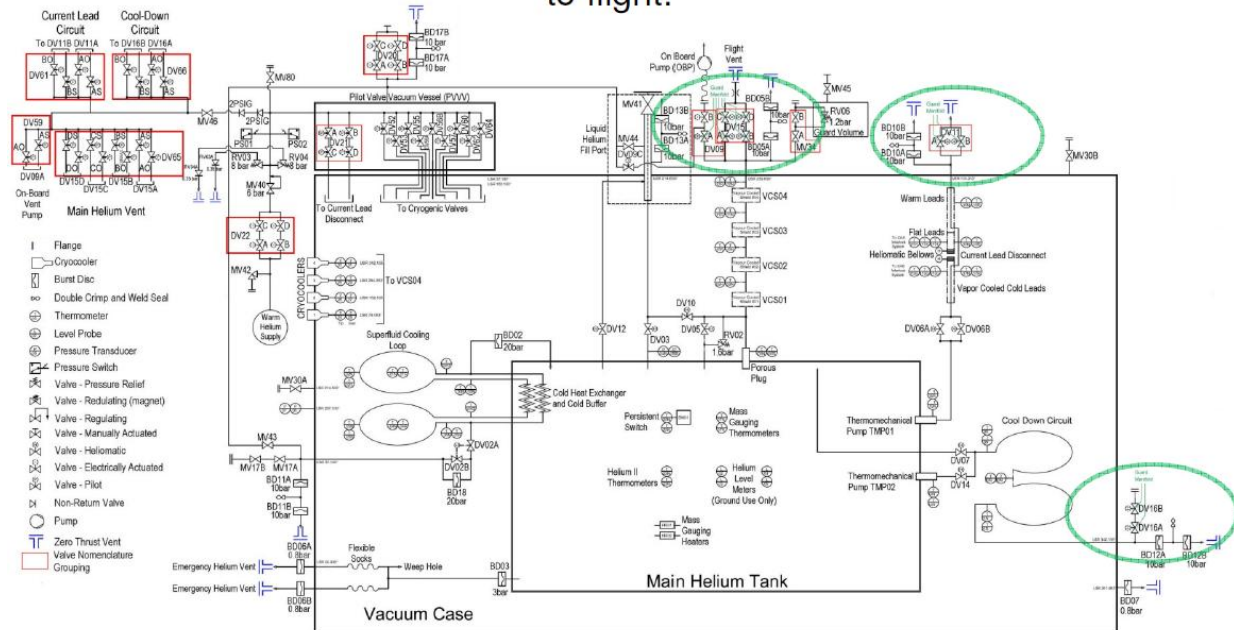
Leakage through stem  
between 10-4 and 10-8 mbarl/s

Guard Manifold show in green  
 Manifold forms single volume that  
 interfaces to GSE and closed prior  
 to flight.

**Corrective Action:** A low pressure plenum is attached to the volume between the middle area (between the two seals) to collect any possible leakage into the cold helium side. A plenum of all nine valves are joined with a 1/8 inch (0.028 inch ID) stainless steel wall manifold that terminates in a Swagelok valve (identical to used for MV45/MV17). Nominally the pressure is maintained with a vacuum or a helium blanket at no more than 1 bar, pressures will not exceed 1.2 bar under worst case conditions.

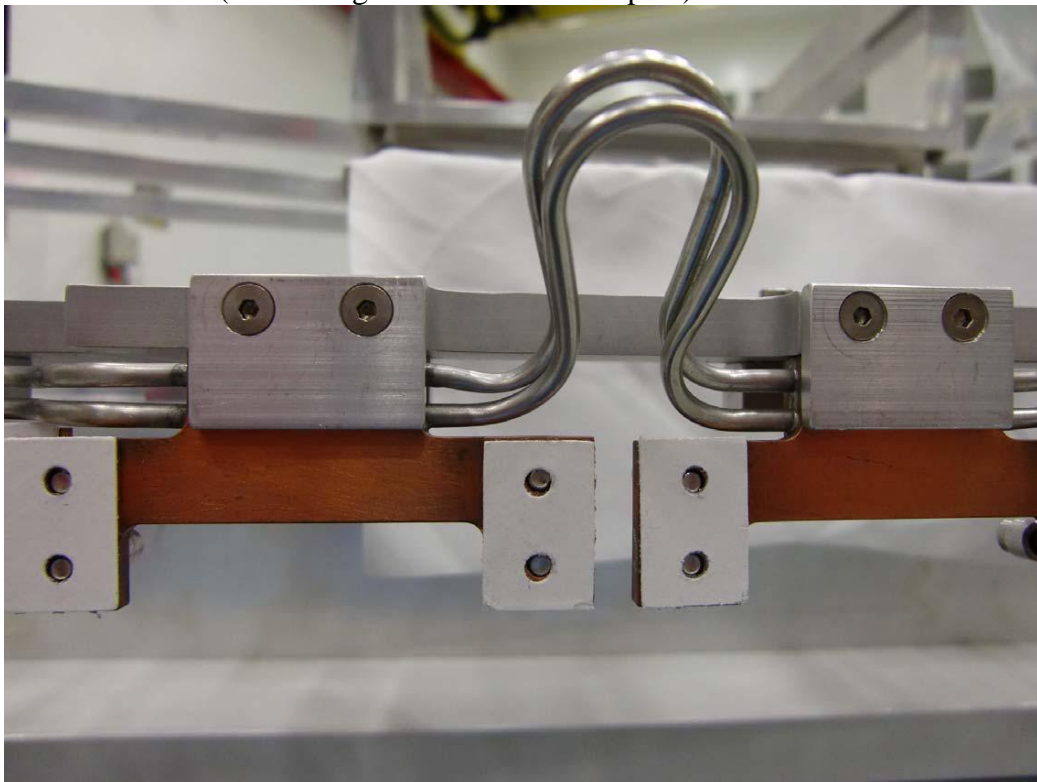
The point of concern was that there was something of a narrowing of the lowering pipe, described by some as a “kink.” This deformation was assessed and deemed not to have compromised the integrity of the piping.

Other Bent Side (after realignment of basic tube path)

**Corrective Action:** During reintegration of the TTCS the tube was carefully bent back into inspections with appropriate bending tools and checked for any damage from the additional working of the tube.
